MS-5012 Field Software Change Procedure

Document 50194 Rev B 3/16/95 ECN 95-133

Firmware Change

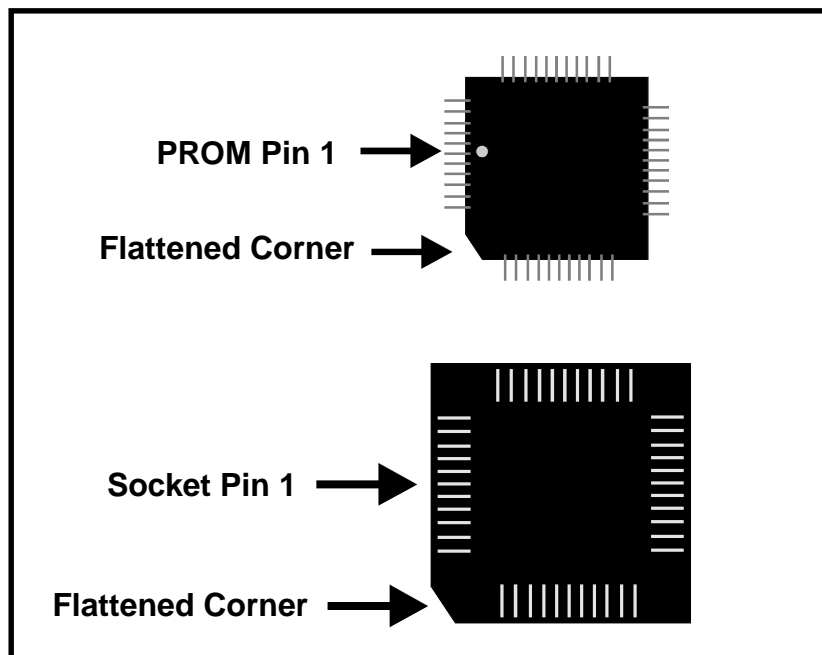
Observe proper orientation of any IC removed or installed! Note location of Pin 1 with respect to the flattened corner and dot on the body of the IC and the relationship to the flattened corner on the IC socket. The replacement PROM must be installed in the same manner as the PROM removed. Failure to observe this orientation will result in destruction of the PROM.
