Technical Bulletin

Products	NX-148E and NX-1192E Version 4.03 Checksum 7B7C
	Version 4.04 Checksum 78E5
Date	April 28, 2006
Issue	Due to a change to the firmware in the NX-148E and NX-1192E keypads, when downloading any text to a zone descriptor higher than zone 10, the keypad's address will be changed. This address change will cause an error to be displayed by the downloader. The message displayed on the downloader will say "Error writing range xy" where x is the module number of the keypad and y is a random number.
	Any additional attempts at the download will result in a message saying, "module is not installed or not downloadable." Also, if a read all or send all command is sent from the DL900 software, the download process will not complete. Even if the keypad is re-enrolled at the new address, no text can be written above zone 10.
	This problem will only occur when using the DL900 software to download, if programming is done from the keypad, this problem does not occur.

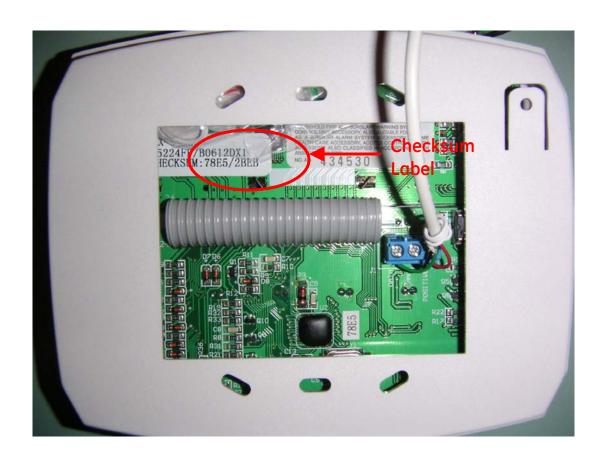
Only keypads with the Checksum numbers identified above are affected. These checksum numbers were manufactured between March 1, 2006 and April 28, 2006.
Solution	The problem has been corrected for both keypads and all future keypads will have updated software that fixes this download issue. If you have a keypad with any other checksums other than those listed above, those keypads will not exhibit this downloader issue.
	If a customer has a keypad with the affected checksum, the customer should request a return authorization from customer service for the keypads. A no-charge replacement will be sent to the customer to replace the defective keypad.
	The checksum label on the affected keypads can be found on the rear of keypad, by removing the back mounting plate and looking on the circuit board.
	The Attached photo shows where the checksum label is located.
