## Technical Bulletin

Products	NX-148E and NX-1192E Version 4.03 Checksum 7B7C
	Version 4.04 Checksum 78E5
Date	April 28, 2006
Issue	Due to a change to the firmware in the NX-148E and NX-1192E keypads, when downloading any text to a zone descriptor higher than zone 10, the keypad's address will be changed. This address change will cause an error to be displayed by the downloader. The message displayed on the downloader will say "Error writing range xy" where x is the module number of the keypad and y is a random number.
	Any additional attempts at the download will result in a message saying, "module is not installed or not downloadable." Also, if a read all or send all command is sent from the DL900 software, the download process will not complete. Even if the keypad is re-enrolled at the new address, no text can be written above zone 10.
	This problem will only occur when using the DL900 software to download, if programming is done from the keypad, this problem does not occur.

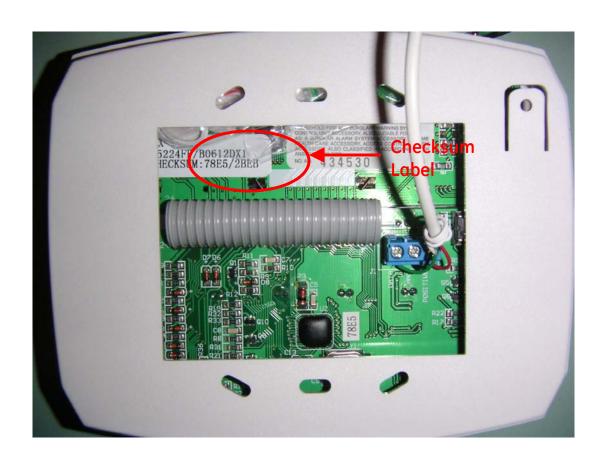
Only keypads with the Checksum numbers identified above are affected. These checksum numbers were manufactured between March 1, 2006 and April 28, 2006.
Solution	The problem has been corrected for both keypads and all future keypads will have updated software that fixes this download issue. If you have a keypad with any other checksums other than those listed above, those keypads will not exhibit this downloader issue.
	If a customer has a keypad with the affected checksum, the customer should request a return authorization from customer service for the keypads. A no-charge replacement will be sent to the customer to replace the defective keypad.
	The checksum label on the affected keypads can be found on the rear of keypad, by removing the back mounting plate and looking on the circuit board.
	The Attached photo shows where the checksum label is located.
