Wireless Door Window Sensors Customer Note

Product Wireless Crystal Door/Window Sensors
60-362-10-319.5 (Standard) / NX-650
60-362-11-319.5 (Standard) / NX-651
60-641-95 (Long Life) / NX-652
60-641-11-95 (Long Life) / NX-653
60-499-10-319.5 (Slim Line) / NX-452
60-499-11-319.5 (Slim Line) / NX-453

October 12, 2006

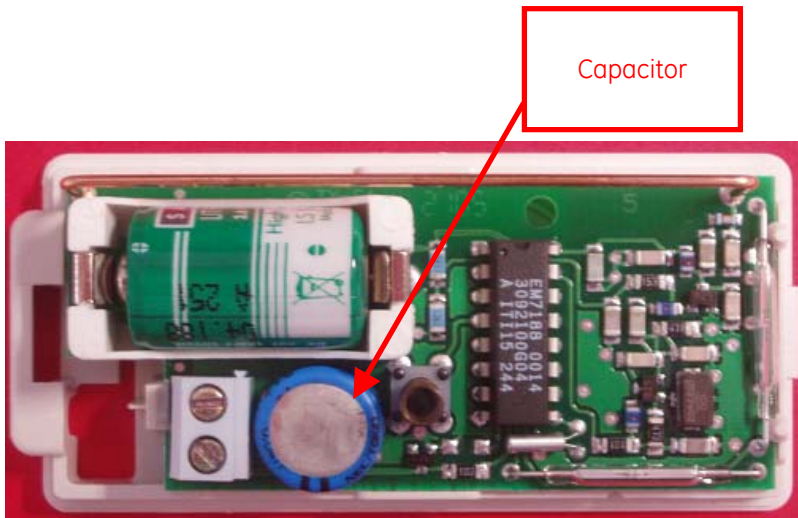
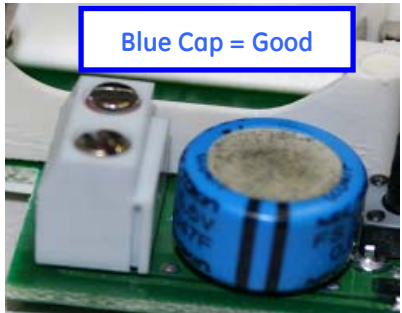
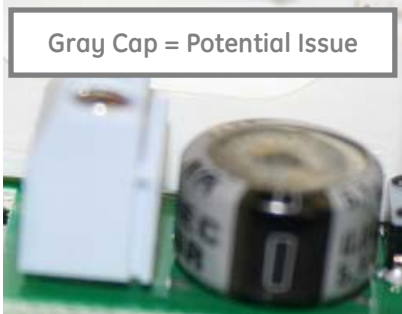
GE Security worked with dealers and determined this low-battery condition is a result of an issue with a capacitor in the DWS. The capacitor issue is limited to capacitors supplied by one specific vendor. These capacitors are easily identified by an installer or service technician, as the capacitor is **GRAY**. Capacitors that are **BLUE** or **GREEN** are **not** affected by this notice.

Please reference the attached photos for capacitor identification.

Solution After identifying this issue, GE Security changed vendors and the manufacturing process so that only **BLUE** or **GREEN** capacitors were used. In addition, all existing stock was fitted with these capacitors to eliminate this issue.

If a DWS was installed for a user during the affected time period, utilizes a gray capacitor, and is exhibiting the low battery/supervisory signal issue, please contact GE Security Customer Service at 888-GESECURITY (437-3287) and request a return authorization. When making this request, please ask the customer service agent to note that this return is due to the **"Low Battery Super Cap Issue"**. A replacement sensor will be shipped at no charge to the customer.
