# TECHNICAL BULLETIN

ITI Wireless Transmitters

### Low Battery Issue

February 15, 2007

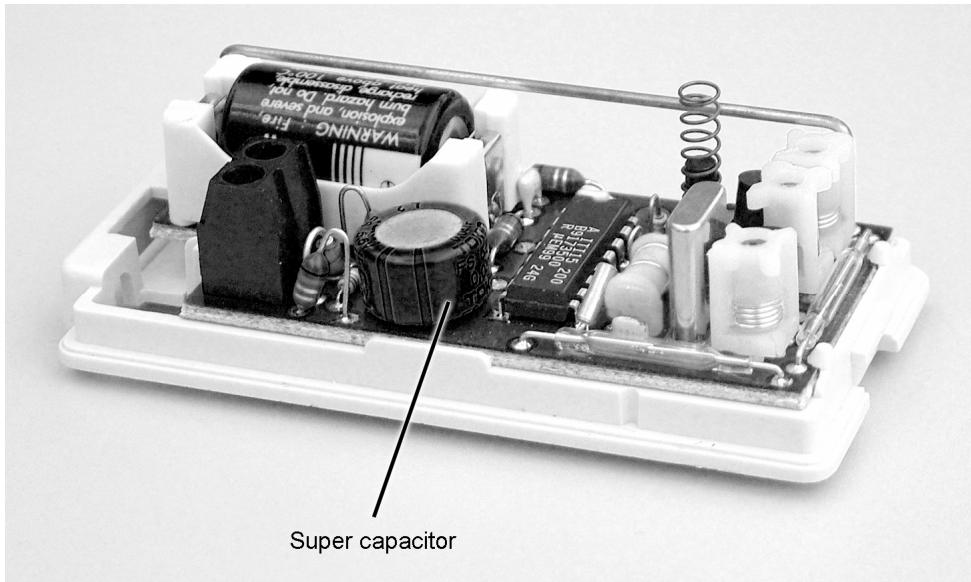
ITI transmitters purchased between February 2004 and June 2005 might send low battery signals to the control panel prematurely. Replacing the batteries fixes the problem for 60 days or less. Only ITI transmitters with a gray super capacitor on the printed circuit board might exhibit this behavior.

Replace all ITI wireless transmitters that exhibit this behavior. For information on what model transmitters are affected, and how to receive a replacement transmitter, refer to the GE Security *Wireless Devices with Gray "Super-Capacitor" Customer Note*, dated November 16, 2006. You can download this document from the GE Security web site at: <http://www.gesecurity.com/GESecurity/images/DWS%20customer%20notice.pdf>.
