## MS-9200(C)/E Field Software Change Procedure (and Programming Existing MS-9200 Systems for use with the LCD-40)

Document #50053 Rev. L 4/23/02  
ECN 02-218 P/N 50053:L

### Firmware Change

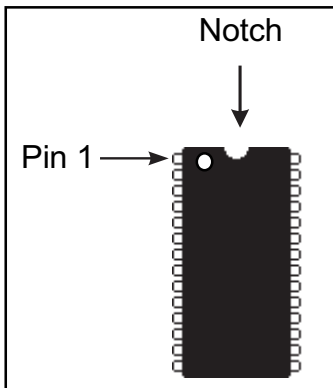
Observe proper orientation of any IC removed or installed! Note location of Pin 1 with respect to the notch in the body of the IC. The replacement EPROM must be installed in the same manner as the EPROM removed. Failure to observe this orientation will result in destruction of the EPROM. *NOTE: Some ICs may have a small dot instead of a notch for orientation purposes.*
