MS-5024UD/MS-5024UDE Field Software Change Procedure

Document 50125 Rev L 11/12/04 ECN 04-639

Firmware Change

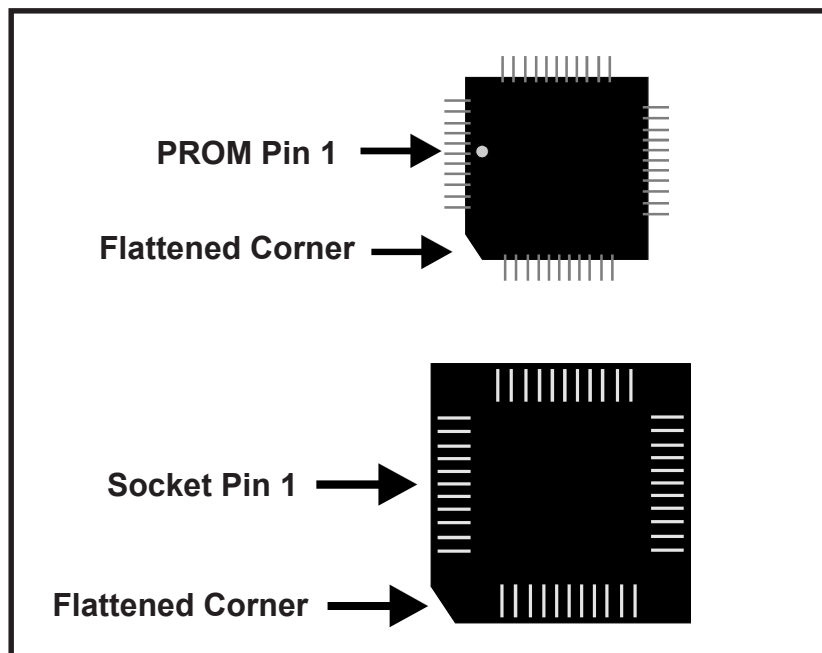
Integrated Circuit Pin Conversion

Observe proper orientation of any IC removed or installed! Note location of Pin 1 with respect to the flattened corner and dot on the body of the IC and the relationship to the flattened corner on the IC socket. The replacement PROM must be installed in the same manner as the PROM removed. Failure to observe this orientation will result in destruction of the PROM.

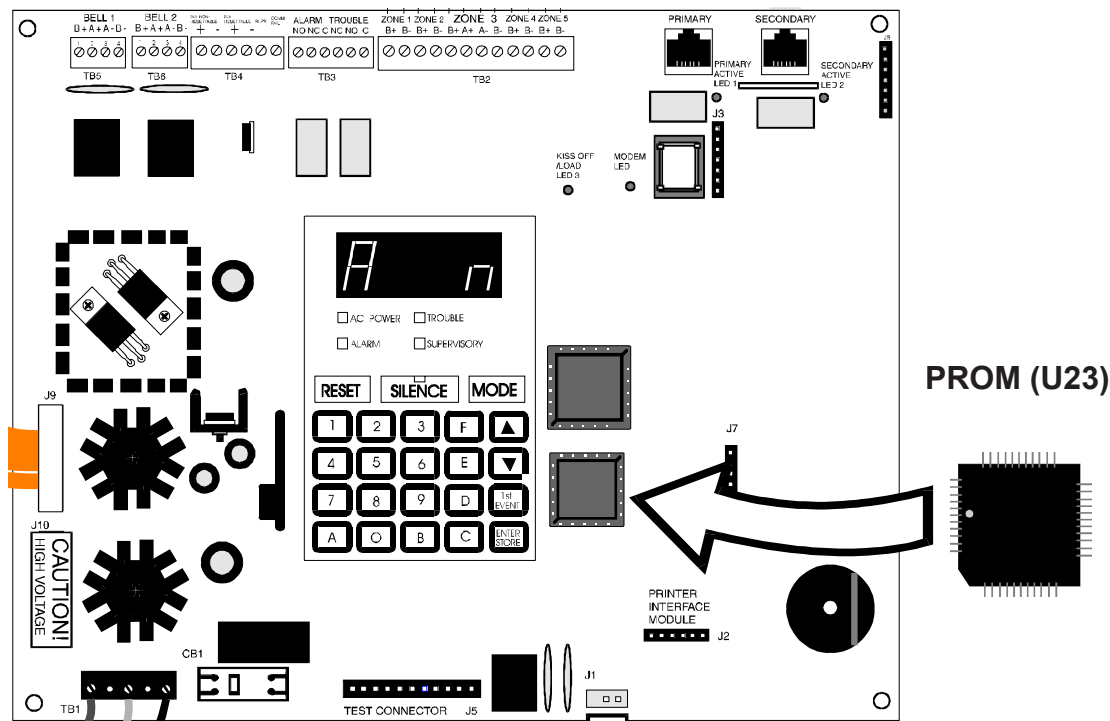
PROM Replacement

Observe proper orientation of any IC removed or installed! To replace the PROM, complete the following steps:

1. Remove all power (AC and battery) before proceeding with PROM replacement.
2. If necessary, disconnect any installed option modules which may inhibit access to PROM.
3. Locate U23 (center right of the board).
4. Gently loosen and remove the PROM from U23.
5. Install the replacement PROM in location U23. Observe proper orientation! The dot on the IC should be positioned to the left and the flattened corner of the IC should align with the flattened corner of the socket. Use care to insure that the PROM's pins are not bent or broken during insertion.
6. Reconnect any option modules which were removed in Step 2.
7. Reconnect power (AC and batteries).
