Fire•Lite LCD-40 Series Field Software Change Procedure

Document #50373 Rev. D 12/9/98
ECN 98-499 P/N 50373:D

Firmware Change

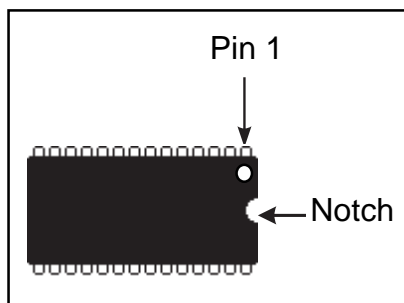
Integrated Circuit Pin Conversion

Observe proper orientation of any IC removed or installed! Note location of Pin 1 with respect to the notch in the body of the IC. The replacement EPROM must be installed in the same manner as the EPROM removed. Failure to observe this orientation will result in destruction of the EPROM. *NOTE: Some ICs may have a small dot instead of a notch for orientation purposes.*

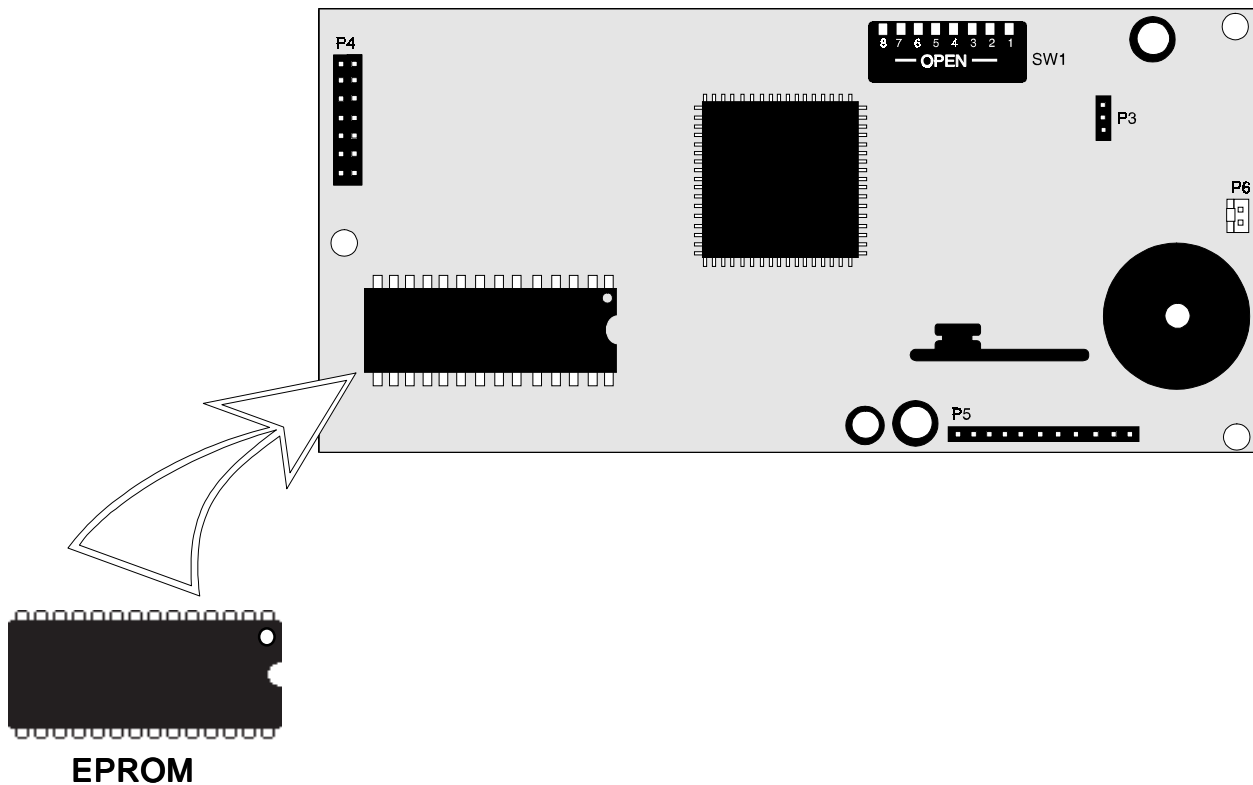
2. Disconnect the two-wire key-switch connector from header P6.
3. Locate the EPROM on the printed circuit board. For EPROM location, refer to illustration below.

4. Gently loosen and remove the EPROM.
5. Install the replacement EPROM. Observe proper orientation! The notch or dot on the IC should be facing toward the center of the board as illustrated below. Use care to insure that the EPROM's pins are not bent or broken during installation.
