Wireless Door Window Sensors Customer Note

Product Wireless Crystal Door/Window Sensors
60-362-10-319.5 (Standard) / NX-650
60-362-11-319.5 (Standard) / NX-651
60-641-95 (Long Life) / NX-652
60-641-11-95 (Long Life) / NX-653
60-499-10-319.5 (Slim Line) / NX-452
60-499-11-319.5 (Slim Line) / NX-453

October 12, 2006

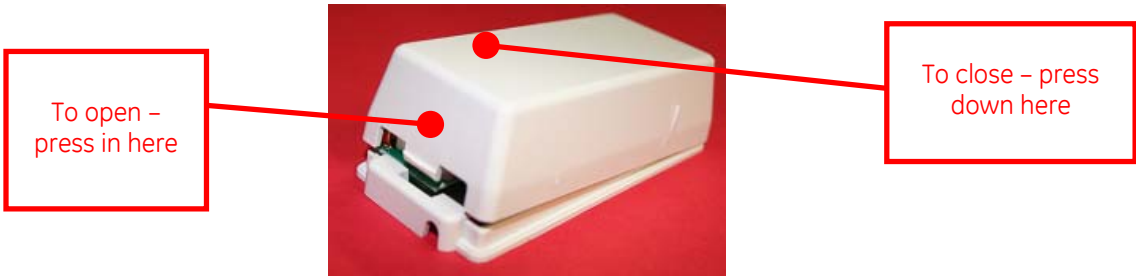
GE Security worked with dealers and determined this low-battery condition is a result of an issue with a capacitor in the DWS. The capacitor issue is limited to capacitors supplied by one specific vendor. These capacitors are easily identified by an installer or service technician, as the capacitor is **GRAY**. Capacitors that are **BLUE** or **GREEN** are **not** affected by this notice.

Please reference the attached photos for capacitor identification.

If a DWS was installed for a user during the affected time period, utilizes a gray capacitor, and is exhibiting the low battery/supervisory signal issue, please contact GE Security Customer Service at 888-GESECURITY (437-3287) and request a return authorization. When making this request, please ask the customer service agent to note that this return is due to the **"Low Battery Super Cap Issue"**. A replacement sensor will be shipped at no charge to the customer.
