Release Notes for Version 6.51

December 2003

Refer to the *D7212G Program Entry Guide* (P/N: 4998138538) when programming the D7212G Control Panel.

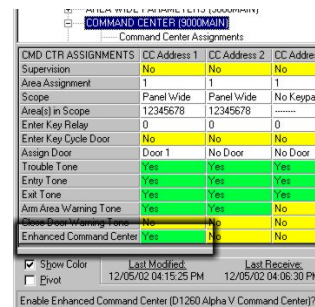
Figure 1: Enhanced Command Center Prompt in RPS

- To enable D1260 Keypads, set the command center menu item to YES for the command center addresses on which the D1260s reside.
 - In the Command Center Assignments section, this prompt is called *CC#EnhanceCmdCtr*.
 - In the COMMAND CENTER (9000MAIN) section in RPS, this prompt is called *Enhanced Command Center*. Figure 1 assumes the D1260 is assigned to CC Address 1.

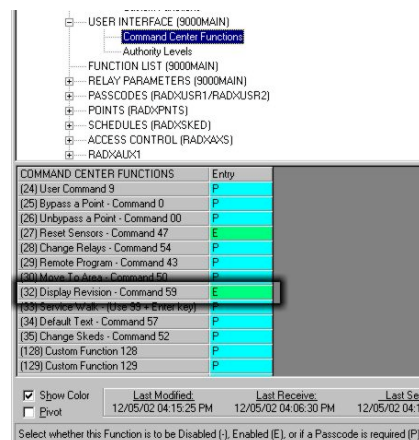
Figure 2: Enable Display Revision Prompt in RPS

2. At power up, each D1260 checks the firmware revision number that resides in the panel. For each D1260 to work, the Display Revision (Command 59) must be enabled and not passcode protected.

- In the D5200, this function is located at:
9000MAIN → USER INTERFACE → Cmd Center Functions → Display Rev)
- In RPS (see *Figure 2*), this function is located at:
USER INTERFACE (9000MAIN) → Command Center Functions
